FACILITY COMPLIANCE AUDIT REPORT

Division of Waste Management Solid Waste Section

Brandywine Industrial Park NC Hwy 4 Battleboro, North Carolina 27809

Comprehensive Audit

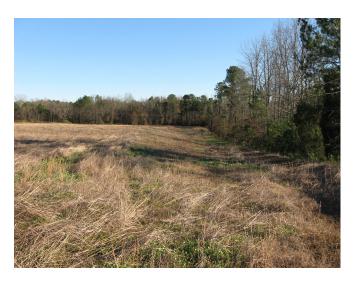
View of the surface of the site facing north east
